**Project Summary**

*In-Situ Geochemical Stabilization (ISGS)* was utilized at a site located near Fanwood, New Jersey to remediate soils and groundwater impacted by the historical release of coal tars and heavy ended petroleum compounds. The compounds of concern included benzene, Benzo(a)anthracene, Benzo(a)pyrene, and multiple other VOC and SVOC contaminants. The in-situ program covered a total area of 8,955 square feet and treated soil and groundwater from 5-10 ft. below ground surface. The remedial liquids were injected into 44 points via direct push technologies (Fig.1). Two intervals between from 5-7 and 8-10 feet below ground surface (bgs) were used to inject the liquids into the targeted media affecting a radius of 7.5 feet for each point.

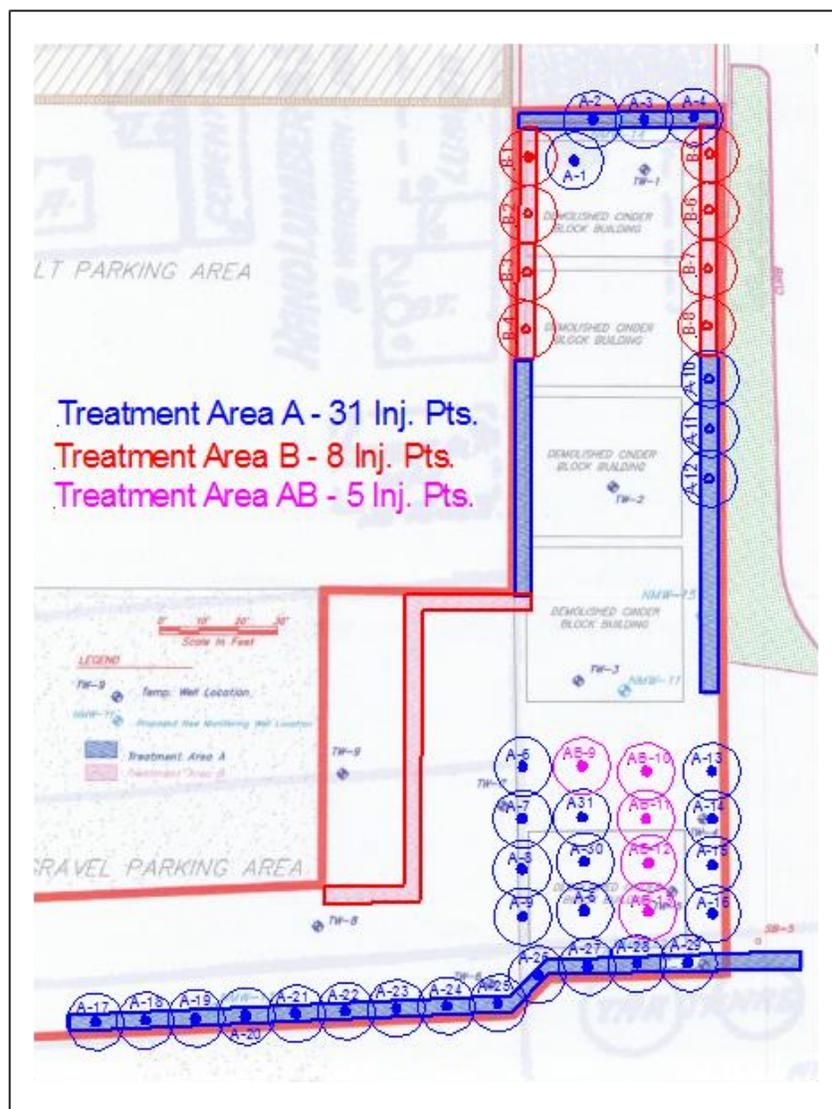
**Figure 1.** Site map showing the location of 44 in-situ injection points.

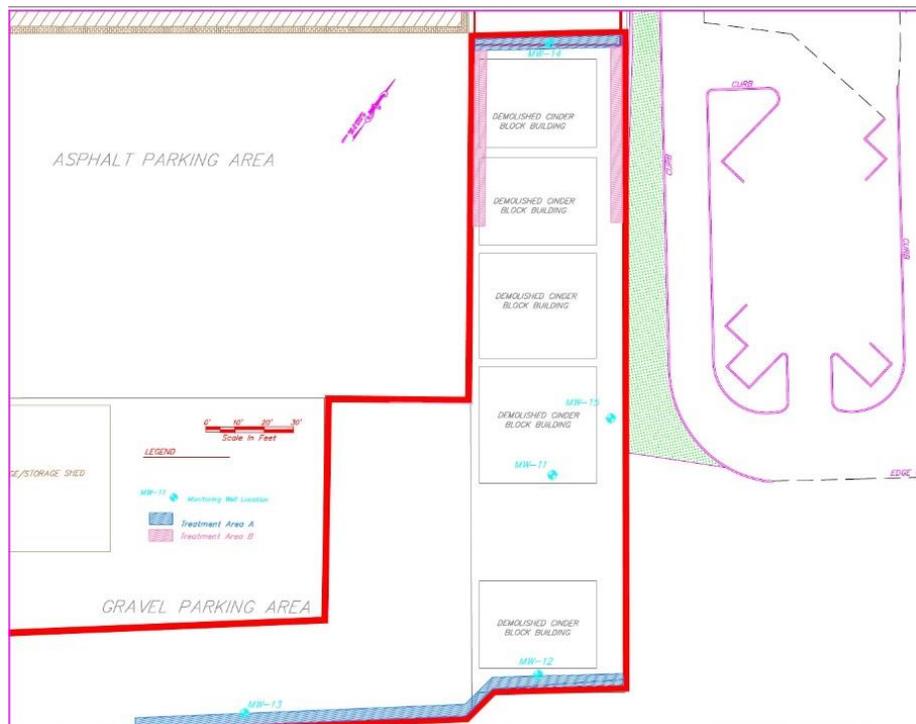
Five monitoring wells were sampled during the baseline sampling event of August 2013 and the first two post-injection sampling events. These wells are: MW-11, MW-12, MW-13, MW-14 and MW-15. The locations of the five monitoring wells are presented in the map below.

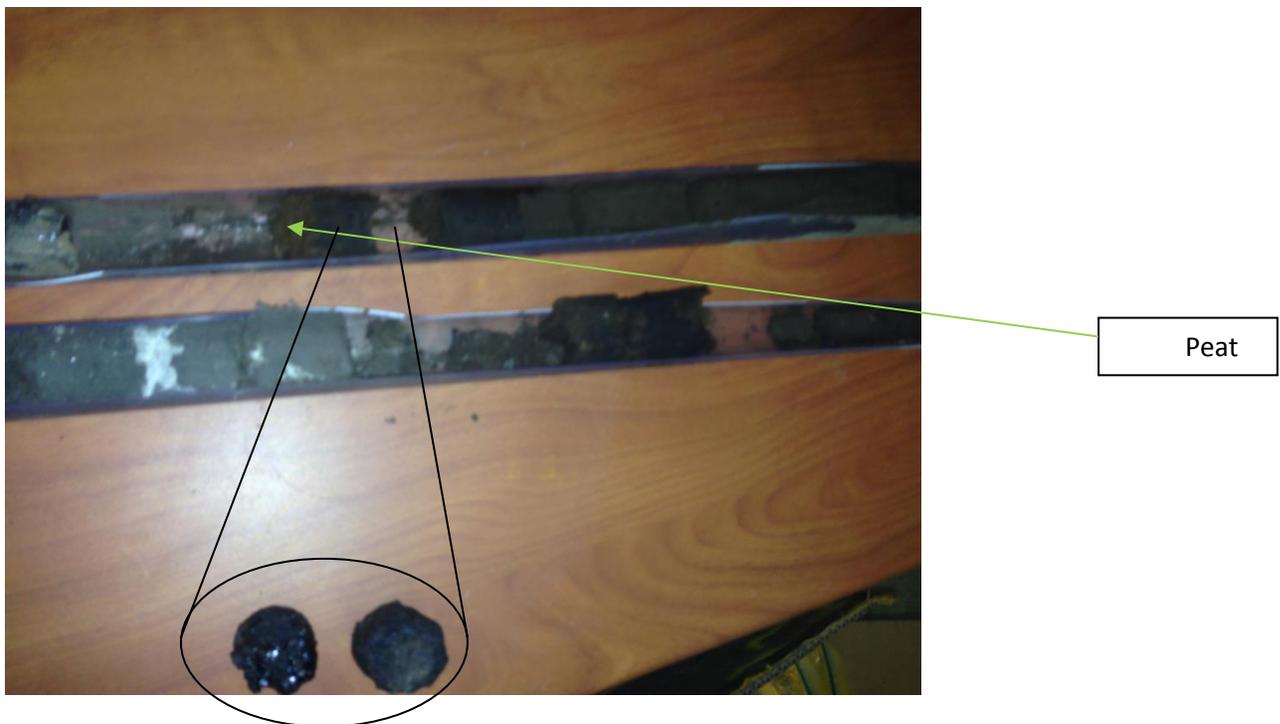
Two pictures of the received soil samples are presented below. It appears that following the ISGS solution injection the creosote with the strong odor that was observed above the peat layer was able to “solidify”, with no associated odor (15 days following injection). In the picture below the peat layer is easily seen and the ISGS formation immediately above it.

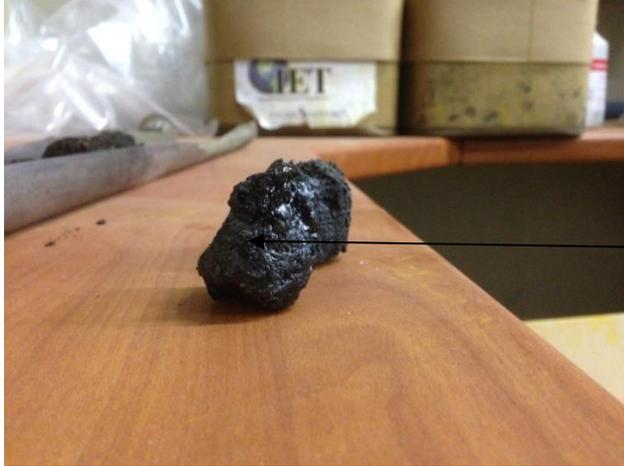
Close-up of ISGS
